Hurricane Matthew: Sources of Flooding and Mitigation Strategies in Lumberton, NC

September 2017

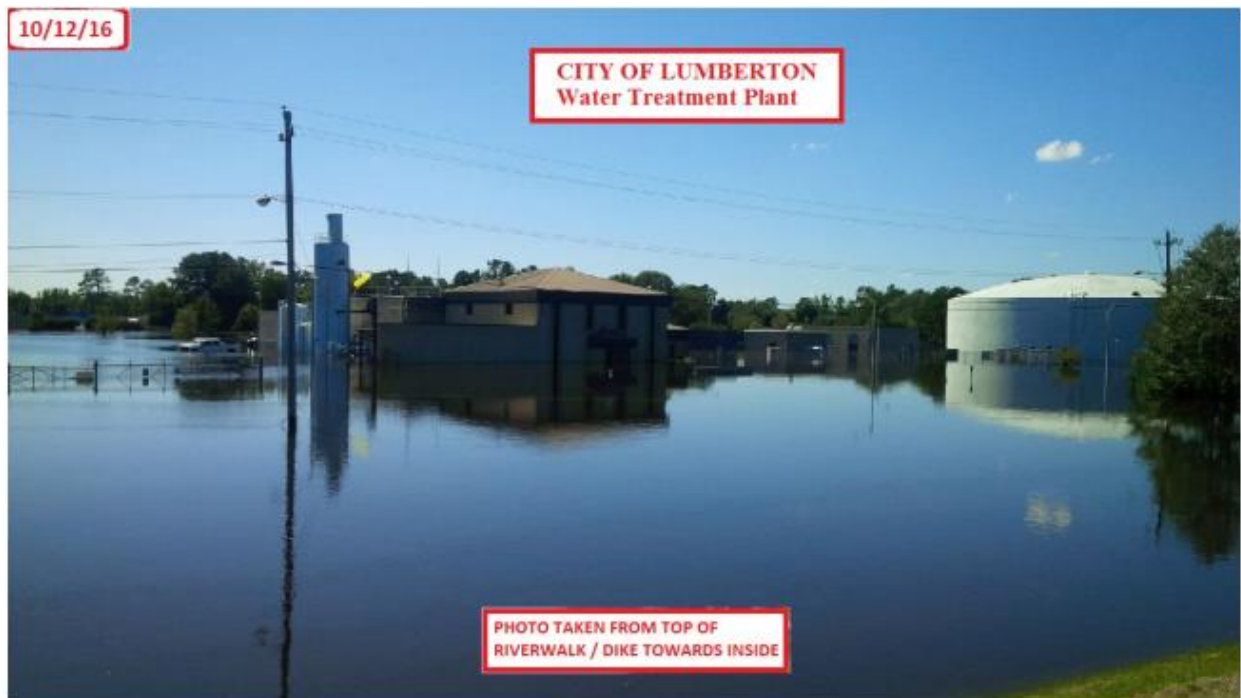
Figure 2: City Water Treatment Plant Flooded to Depths up to 4 Feet

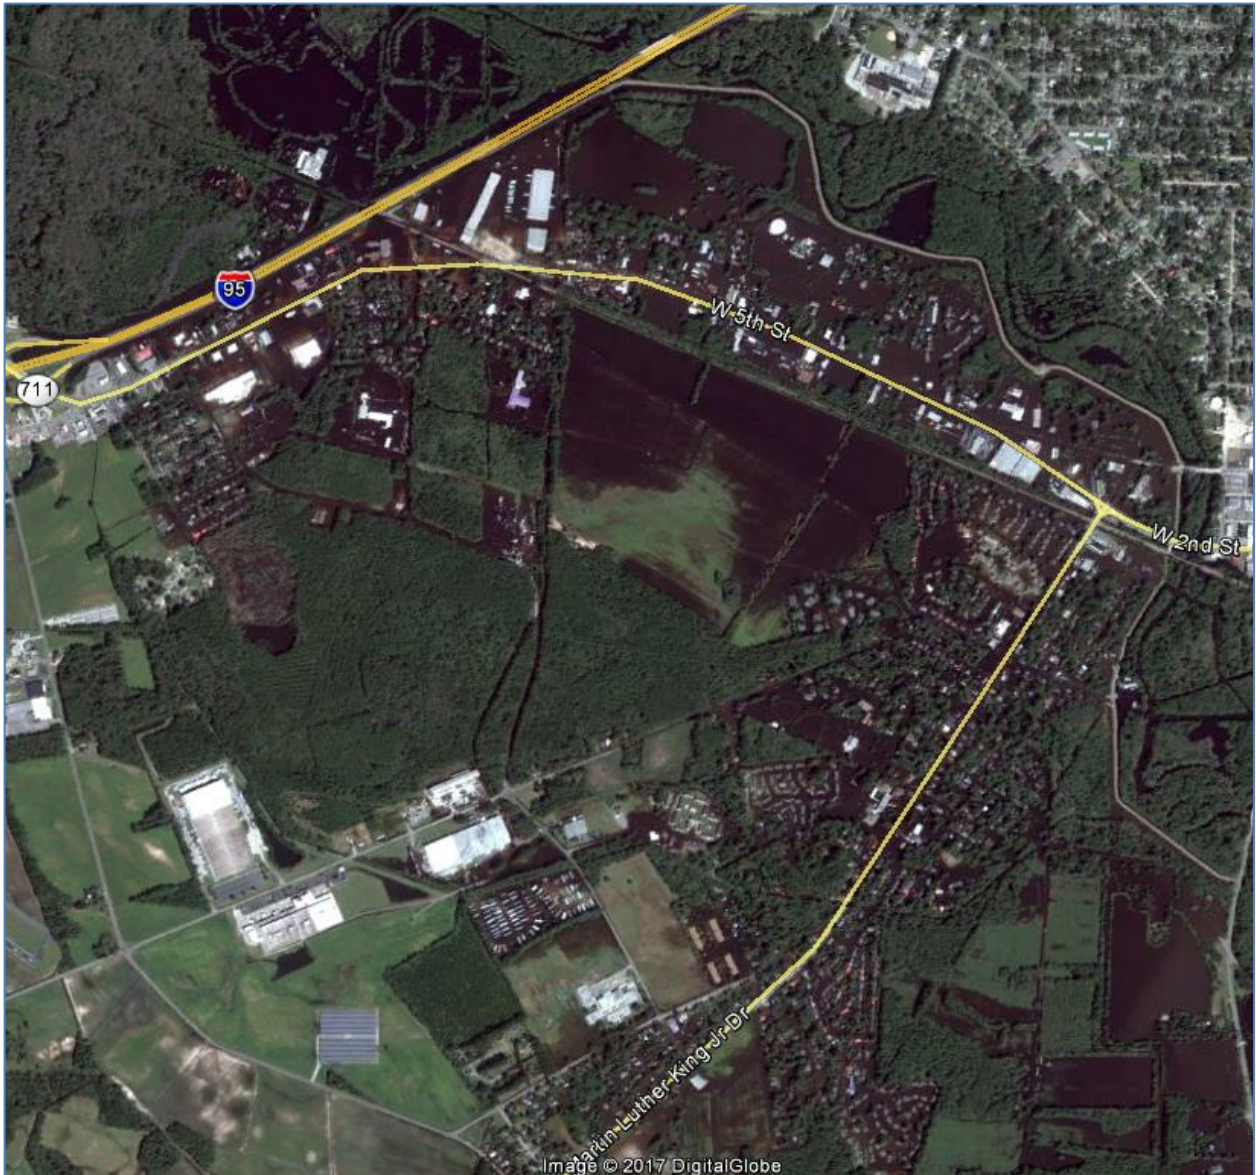
Figure 5: Extent of Flooding in Lumberton due to Hurricane Matthew

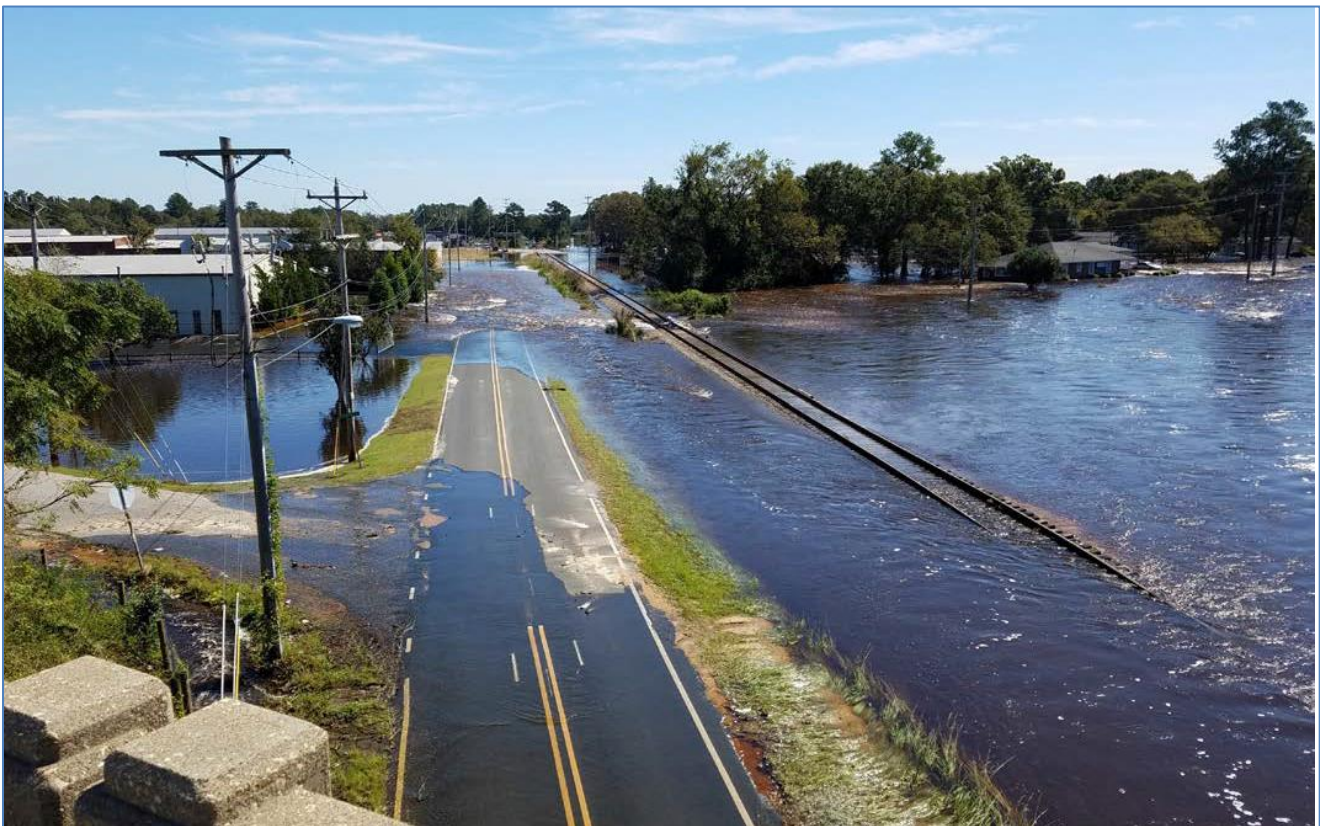
A Trip Report developed following a field visit by the USACE on October 11, 2016 documents that significant flow from the Lumber River passed through the VFW Road underpass. This report is included as Appendix G: USACE Lumberton Trip Report – 20161011. Once the water overtopped the railroad, which is at an elevation of approximately 121.5', the floodwater went south through the railroad ditch to the low spot on VFW Road which is at an elevation of approximately 117.5'. The photo in Figure 7 below show water flowing south through the underpass at estimated velocity of between 6 and 8 feet per second and flooding areas to the west of the railroad and to the east of VFW Road. Figure 8 shows the scour that resulted from the high velocity flow. These photos were taken during the USACE field visit at approximately 1PM on October 11th, some 30 hours after the peak stage recorded at the USGS gage location at the upstream face of the 5th street crossing. During the dewatering process, NRCS estimated that considering the damage and scour at VFW Road and the railroad, water would continue to exit to the north under the VFW Road crossing until it reached an elevation of approximately 118', or about 7 feet below the recorded high water mark in the vicinity. As of October 13th, three days after the peak gage reading, water was still flowing across VFW Road.

Figure 7: Water flows south from VFW Road Underpass Washing Out Railroad and Overtopping VFW Road

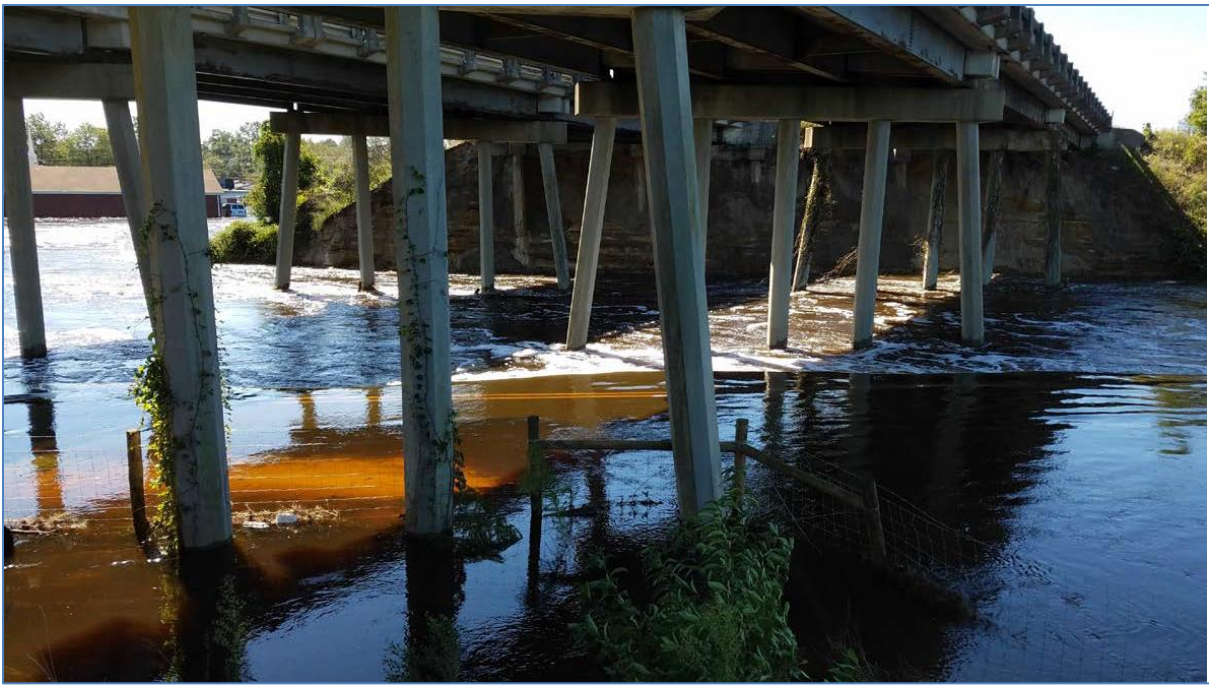
Figure 8: I-95 Abutments Eroded on SW Side of Underpass. Railroad not Apparent

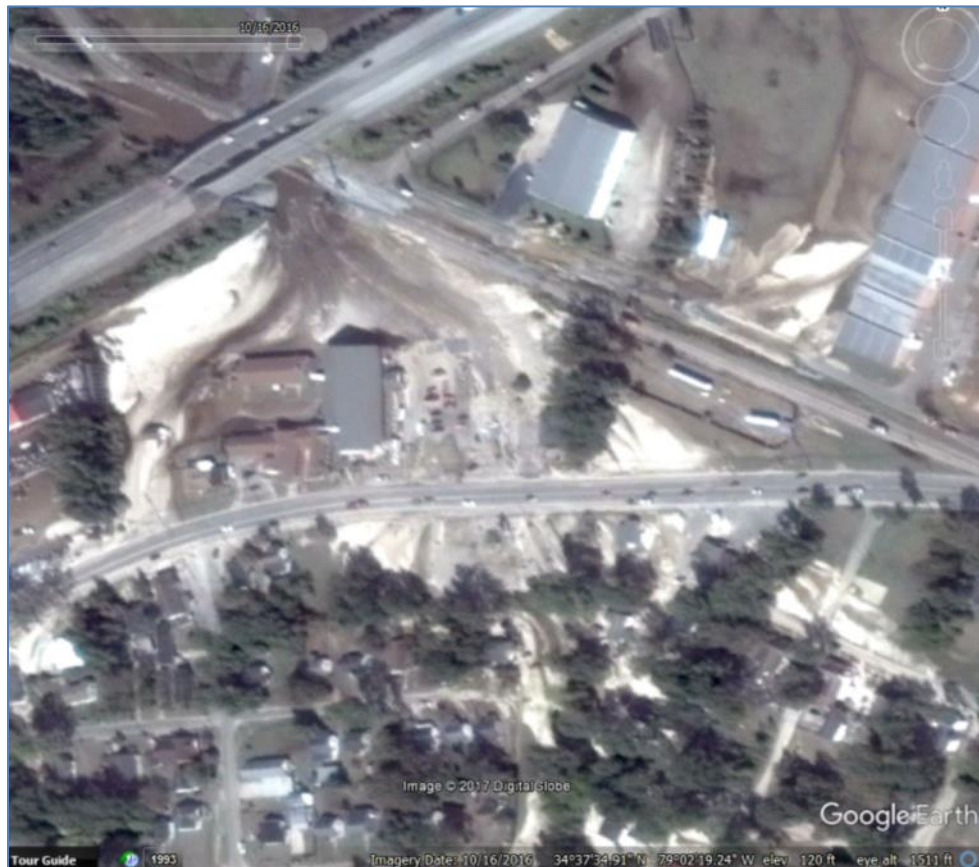
In Figure 9, imagery from 10/16/2016 shows deposits made by the rapidly flowing water as it passed under I-95, eroded the abutment, and made its way into the southern and western parts of the City.

Figure 9: Deposits Mark Path of Flow to South of Railroad and North of VFW Road

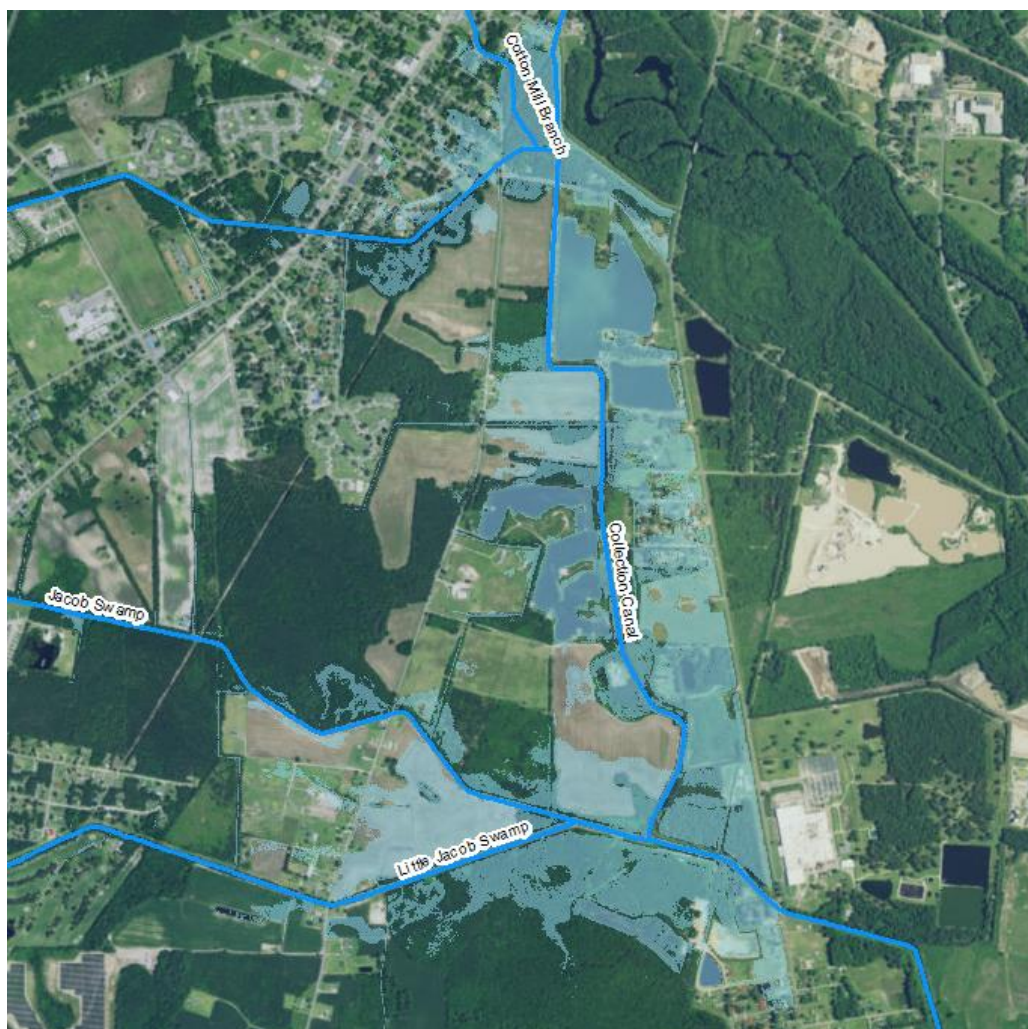
elevation for the river at the bridge during the 1% annual chance event flood is approximately 112.85'. Figure 10 shows the area that would be inundated based on the backwater from the Lumber River at this elevation.

Figure 10: Inundation Potential from Lumber River Backwater at Jacob Swamp Bridge (SR 2289)

During a 1% annual chance event flood, backwater from the Lumber River alone has the potential to impact approximately 66 structures, all of which are classified as residential. Under ideal circumstances, the local drainage canals will have passed their peak flood stage by the time the Lumber River approaches its crest. However, if the interior drainage system is taking on water from another source, such as flow through the VFW Road underpass at I-95, the Lumber River backwater will significantly reduce the conveyance in the already undersized drainage canals. The result will be significant flooding throughout the Jacob Swamp watershed as it takes on water from the underpass and at the same time is unable to effectively drain. Water surface elevations above 115' were reported near the outlet under Alamac Road.

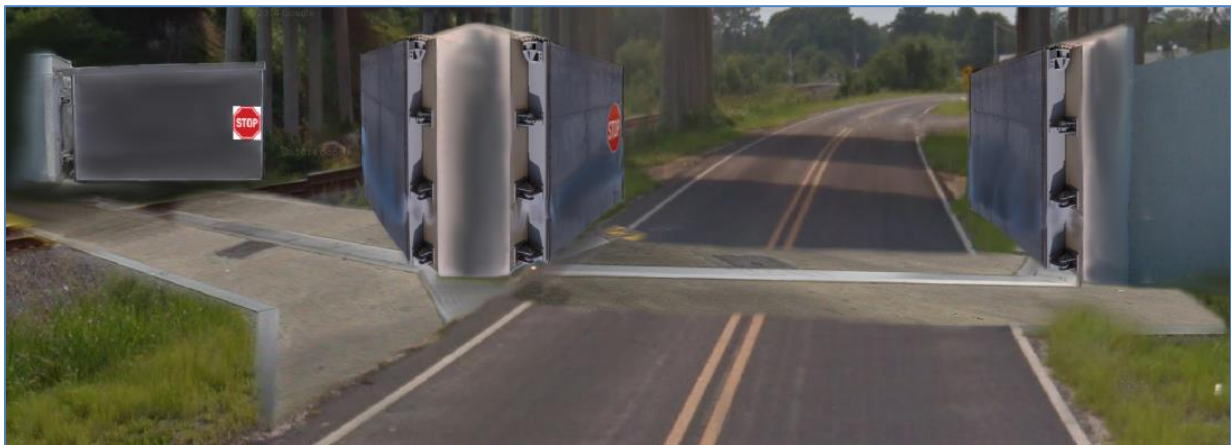
Figure 11: View of Flood Gate from VFW Road Looking North Toward I-95

The recommended primary gate design would be a swing gate with the width of the gate exceeding the roadway crossing by a minimum of 2 feet clear on each side. The concrete monolith that houses the gate would be pile founded. Swing gates are preferred since they can be easily closed by a two-person field crew. A mechanized swing gate would be designed for the location at the underpass of I-95 and VFW Road. Railroad clearances would comply with American Railway Engineering and Maintenance-of-way Association (AREMA) criteria. Figure 11 shows a conceptual view of what these gates may look like at the VFW Road and Railroad closure site. Example technical sketches can be found in Appendix B: Flood Gate Concept.

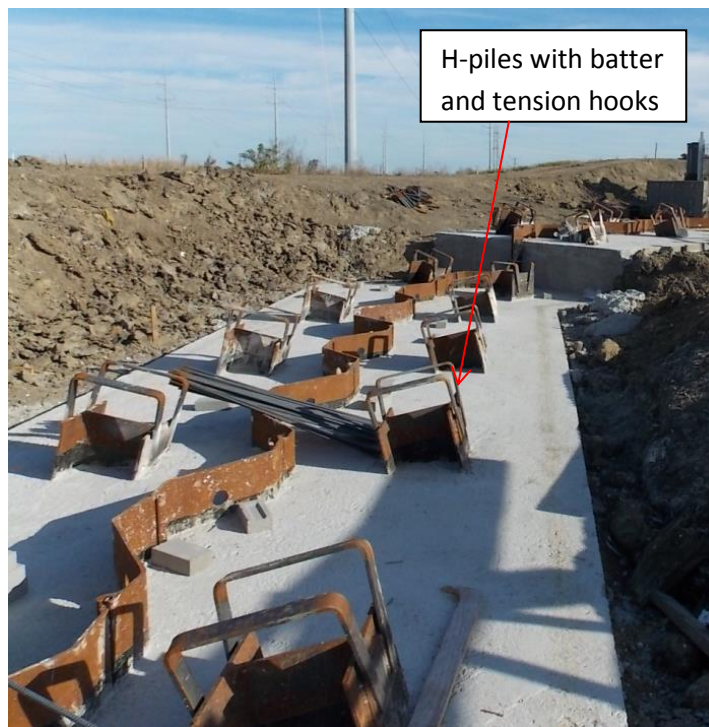
H-Piles would be Grade 50 steel and considered where the rock formation is greater than 50 feet below the surface. Piles would be driven on an approximate 1H on 3V batter to more efficiently resist the lateral hydrostatic loads. Typical pile configuration is shown in Figure 12.

Figure 12: H-piles With Batter and Tension Hooks

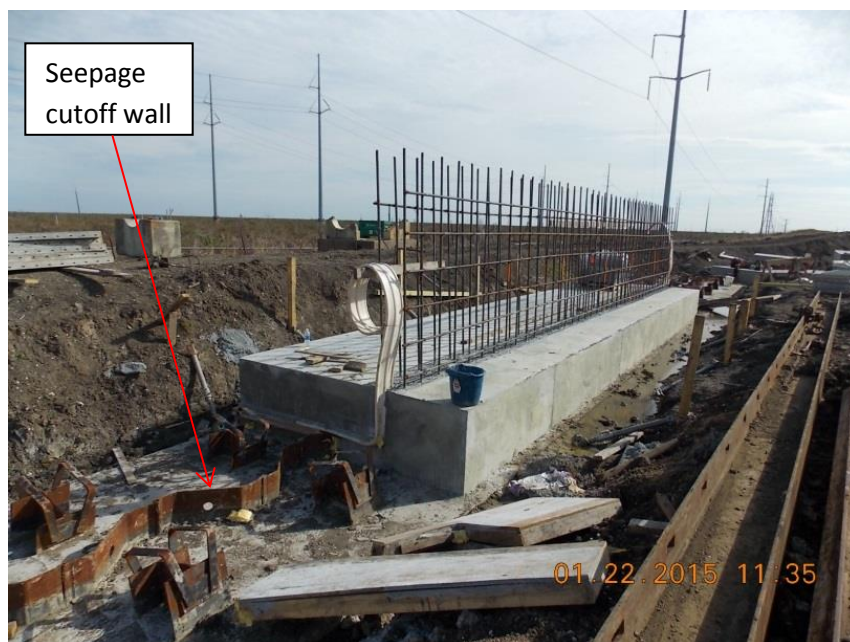
- Seepage Cut-off Wall:** A sheet pile cutoff wall would need to be driven to the bottom of the sheet pile to minimize seepage and prevent piping. Until the final geotechnical borings are complete, it is assumed that the sheet pile would be 20 feet deep. The top of piling would be embedded 6"-9" into the wall base. Figure 13 shows a typical sheet pile cutoff wall.

Figure 13: Typical Seepage Cutoff Wall

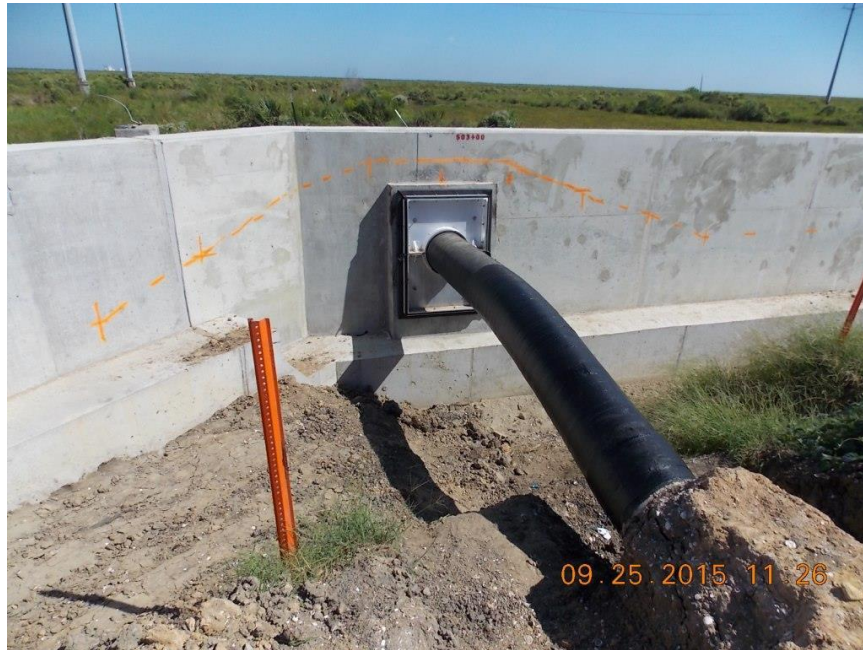
the T-Wall base, but must be passed through a water tight sleeve. Gravity lines, such as storm drainage systems, would include a positive shut off valve and when necessary a flap, duck or backup prevention device. Figure 14 shows a typical utility penetration.

Figure 14: Typical Utility Penetration

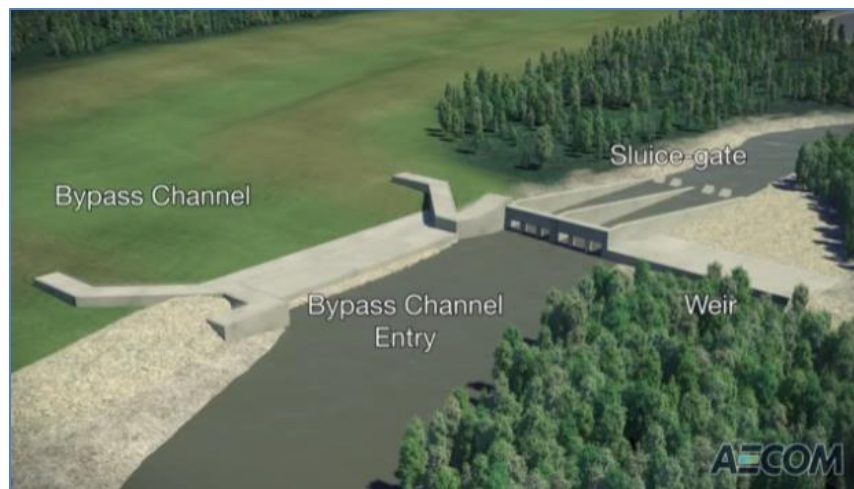
- **Diversion Structure:** In order for the bypass to be functional, a bypass structure would need to be constructed which would likely consist of a low water opening spanning portions of the Lumber River floodplain that would help funnel flood discharges across a lateral weir and into the bypass channel during a flood event. Hardened structures would need to be used in order to enable the accurate prediction and control of flood flows into the bypass. A typical design is shown in Figures 17 and 18 but other variations are conceivable.

Figure 17: Diversion Structure Under Normal Flow Conditions

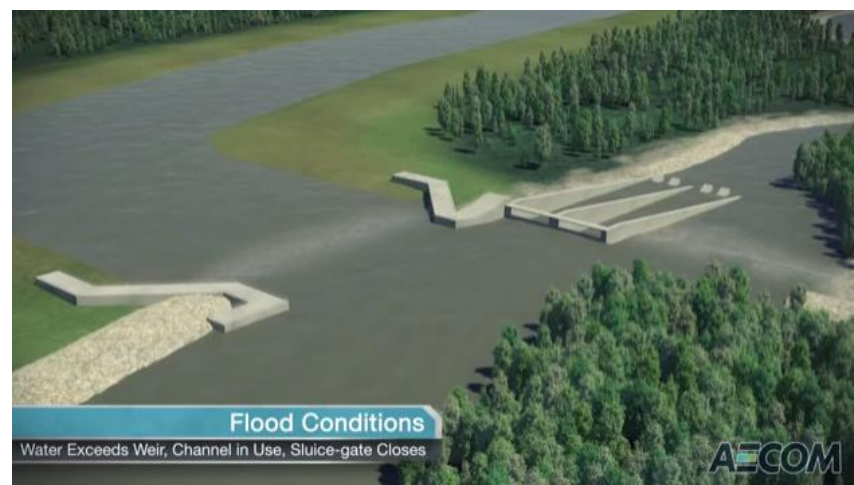
Figure 18: Diversion structure during flood conditions

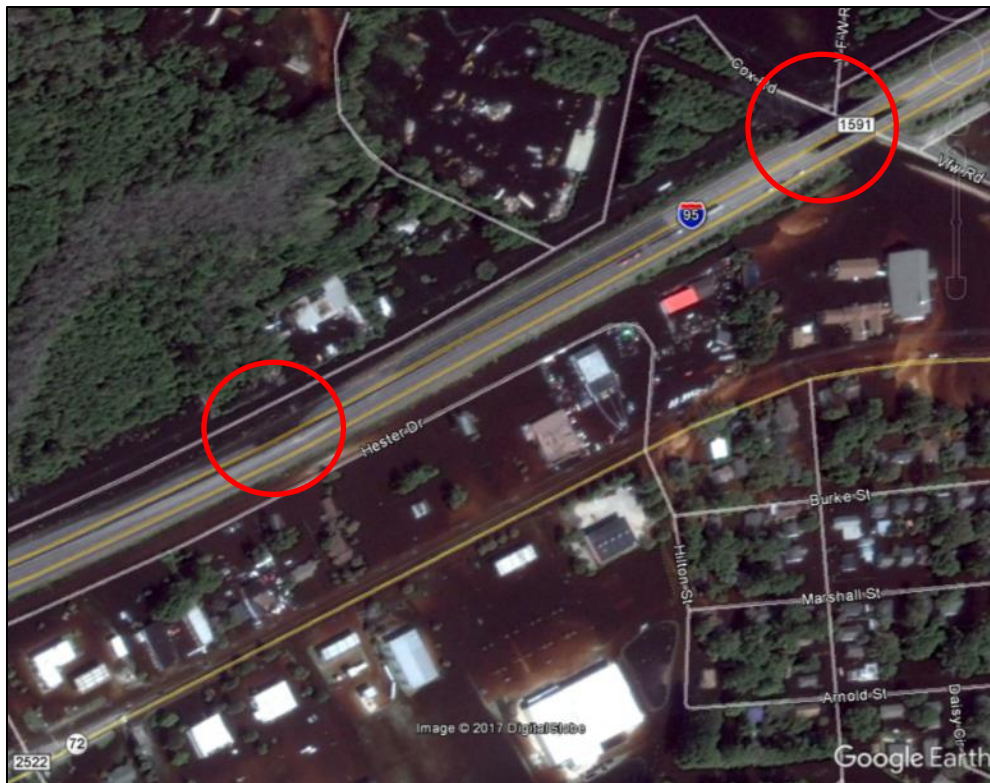
- Sizing the Channel:** The underpass at VFW Road and the low point along I-95 approximately 1,700 feet southwest of the underpass were chosen as critical points to evaluate. These locations are identified in Figure 19. Using the preliminary HEC-RAS model it was determined that approximately 3,000 cfs would need to be diverted to prevent the underpass from being inundated and approximately 5,000 cfs would need to be diverted in order for the low point on I-95 to achieve the required 3 feet of freeboard for levee system certification.

Figure 19: Critical Water Surface Locations
